Disclaimer: Please refer to the complete USG-400 IFU Chapter 8, which is supplied with each item of equipment and should be thoroughly read and understood prior to use of the equipment.

8.1 Troubleshooting

8.2 Error screen

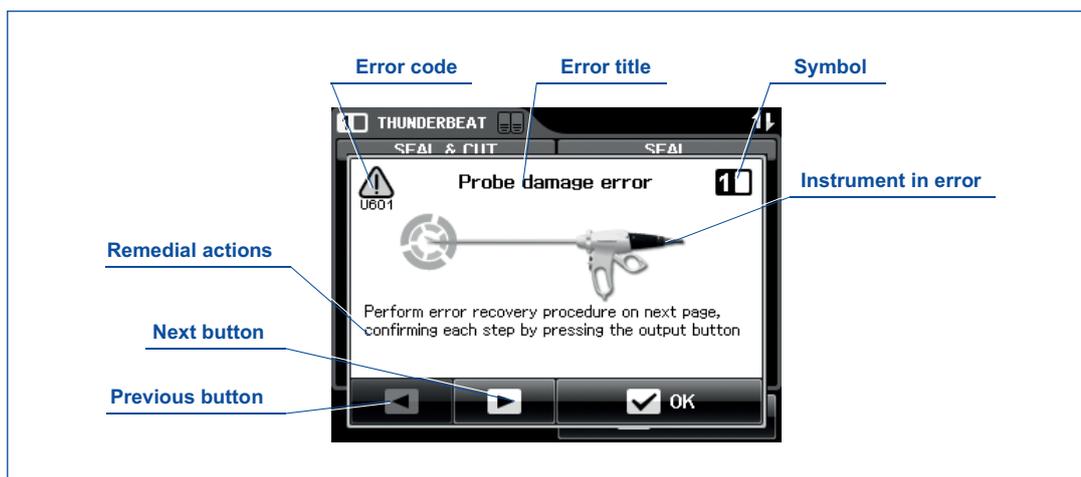
The error window is configured as shown below in Figure 8.1 USG-400 IFU chapter 8.

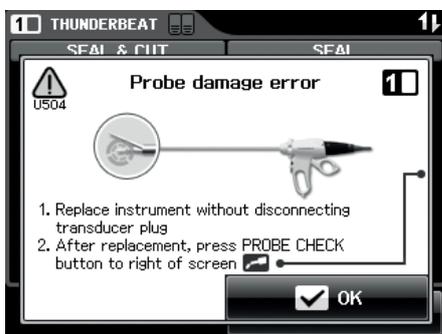
**Error window
(U504: Probe damage error)**

- 1 Without turning off the ultrasonic generator or disconnecting the transducer plug from the transducer socket of the ultrasonic generator, disconnect the handle from the transducer and replace it with a new THUNDERBEAT or SONICBEAT handle.
- 2 Probe check push button
Press the "PROBE CHECK" push button on the right side of the front panel.
The confirmation window (Probe Check) is displayed.

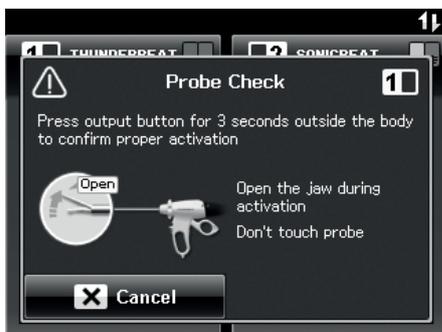
Confirmation window (Probe Check)

- 3 Executing the probe check
With the grasping section open, press and hold the handswitch or footswitch pedal for three seconds and then release it.
 - The probe check starts.
 - The information window (Checking) is displayed.
 - When the check is completed, the information window (Checking) disappears and the probe check result is displayed.

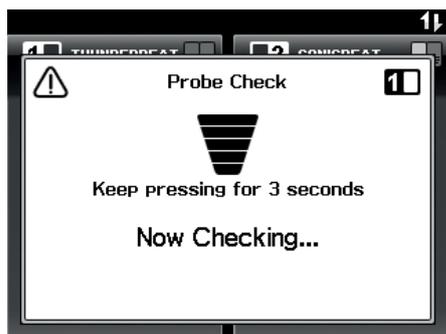
Information window (Checking)

When the activation is completed:

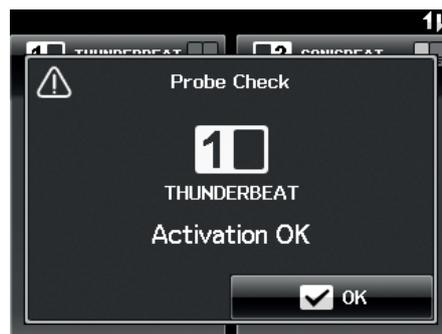
Confirmation window (Activation OK)

- 4 Probe check result
When the confirmation window (Activation OK) is displayed, tap the "OK" button.

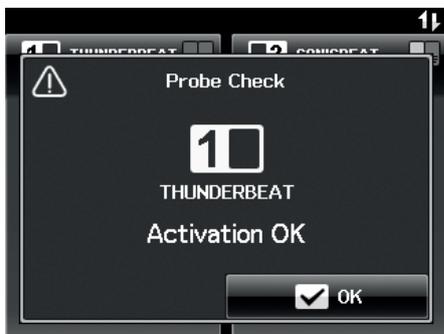
Confirmation window (Activation OK)

The confirmation window (Activation OK) disappears and the "All" screen or "Set" screen is displayed.
